Please Help Preserve our ancestral castle at Ellan Vhow (Island I Vow)

*There are three “Scheduled Ancient Monuments” amongst the islands of Loch Lomond. These are protected by the Scottish Government as nationally important historic sites and are under the care of Historic Scotland. Two of the three, **Inveruglas Isle and Island I Vow (Ellan Vhow)**, are home to the ruined remains of **Macfarlane strongholds**.*

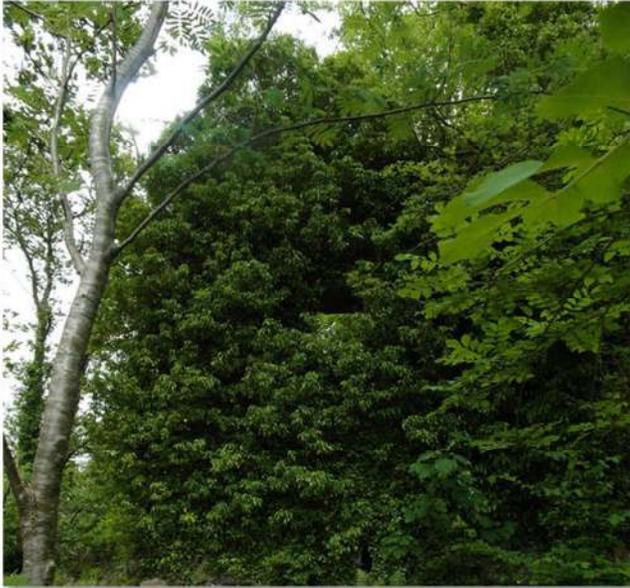
Figure 1 - Ellan Vhow castle overgrown with ivy and threatened by destructive root growth of embedded saplings and mature trees.

Work is planned **this winter** (by licensed professionals under archaeological supervision) to do the next phase of preservation work ... trimming the damaging ivy and coppicing the trees threatening the structure. In addition to helping preserve the structure, this work will clear the way for a thorough, formal archaeological survey and will give visitors a view of the castle not seen for a century or more. **The Ellan Vhow Preservation Fund** has been formed to support this effort and is accepting donations online now.

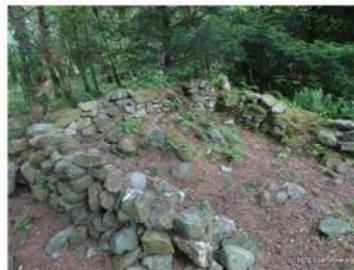
Figure 2 - The eastern orientation and remnants of a possible altar suggest this building may have been a chapel.

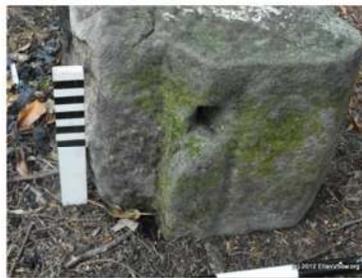
Figure 3 – A finished stone, part of a castle window, was discovered this summer. A vertical groove, designed to receive leaded glass, is clearly visible. Note also the socket for an iron bar to support the leaded glass.

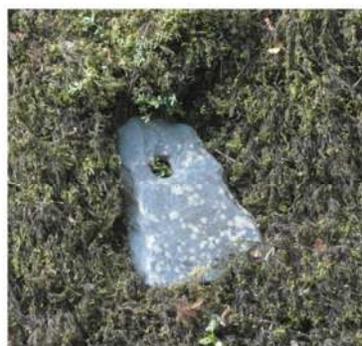
Figure 4 – Several tapered slates were found, suggesting that Ellan Vhow castle had one or more conical towers.
